## **2.0 VISIT TO SITE**

**REPORT ON:  
EXISTING BOILERS & FLUES AT:  
CARNDONAGH CC Co. DONEGAL**

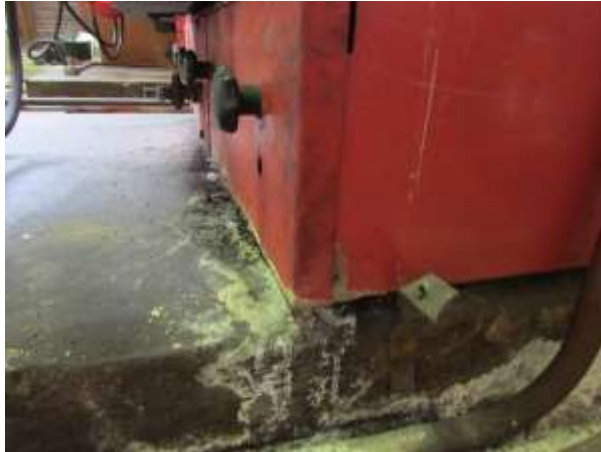
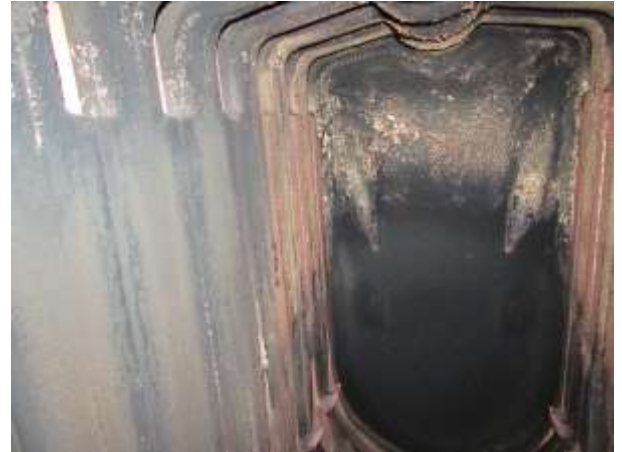
The existing boilers are in very poor condition with the cast iron boiler sections showing signs of leaks at many areas. The product name of the boilers is Hogfors 25, each rated at 360 kW and manufactured in 1986 making them 29 years old.

1. The 2No. Boilers be replaced.
2. The 2No. Burners be replaced.
3. The 2No. flues be removed in their entirety and replaced with new flues in compliance with current Irish standards and guidelines.
4. A number of valves be replaced.
5. The structural steel be fire proofed to retain the desired fire proof rating.

Remove existing oil fired cast iron sectional boilers and replace with new high efficiency models to match existing heat output.

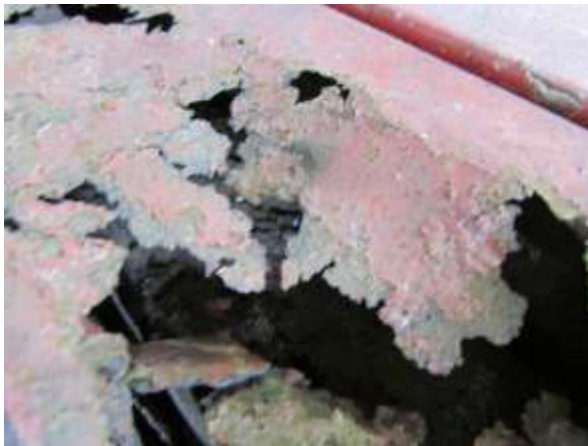
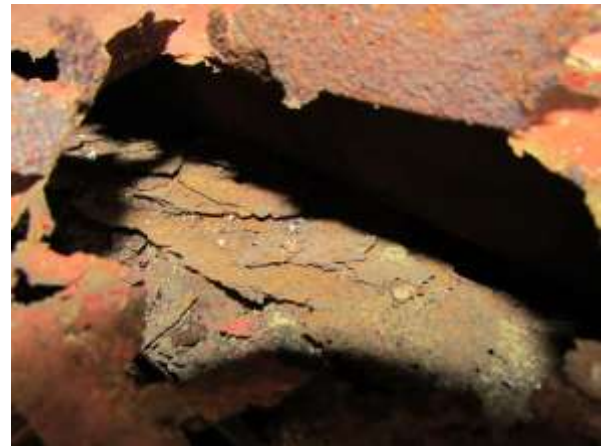
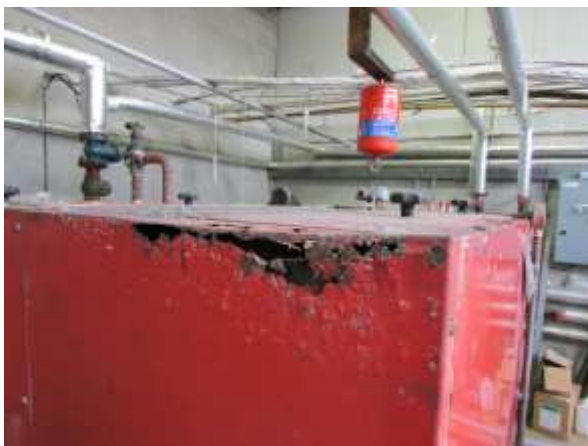
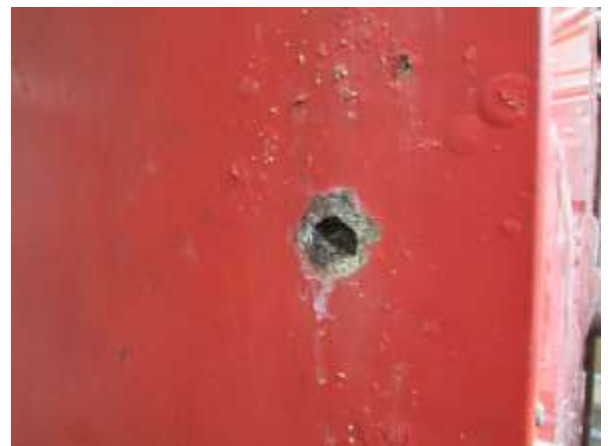
The boiler insulation has deteriorated in many places. As can be seen from the photographs the boiler casings are also corroding due to the leaks in the boiler sections.

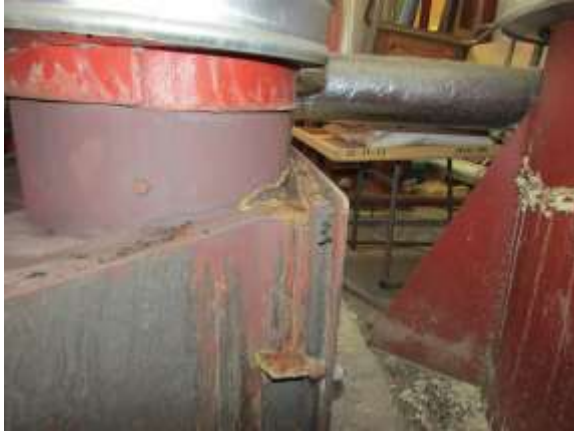
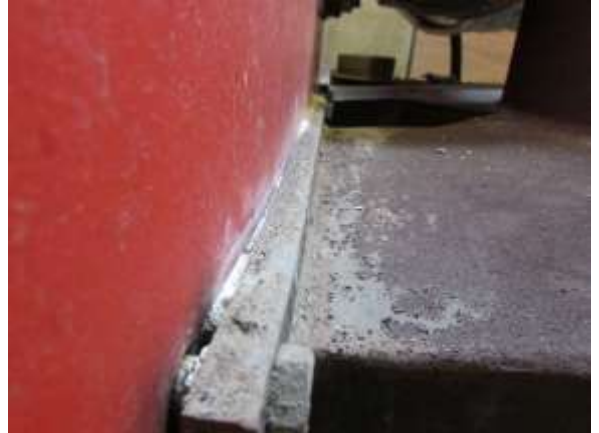
The backend of each boiler are showing signs of corrosion. It is very possible that due to the age of the boilers, the boiler seals and gaskets are manufactured from asbestos.

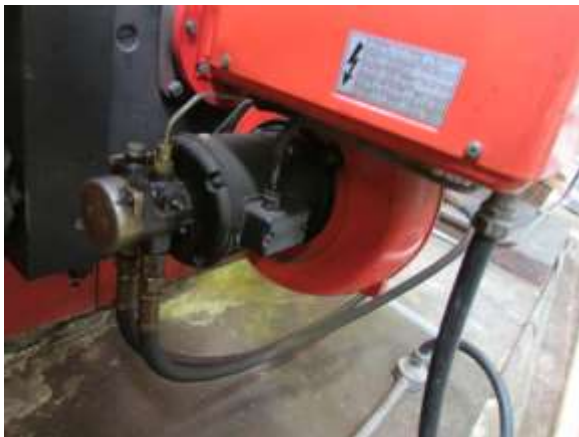
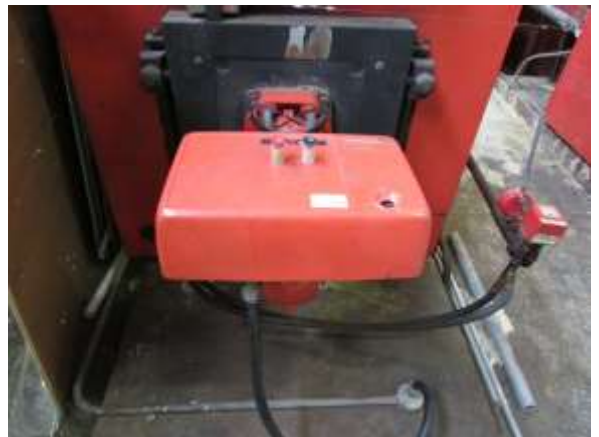
The burners are well maintained but have reached the end of their economic life. Boiler service reports repeatedly raise concerns of parts that require replacement. (see appendix A)

Remove existing problematic burners and replace with new high/low oil fired burners to match new boilers.

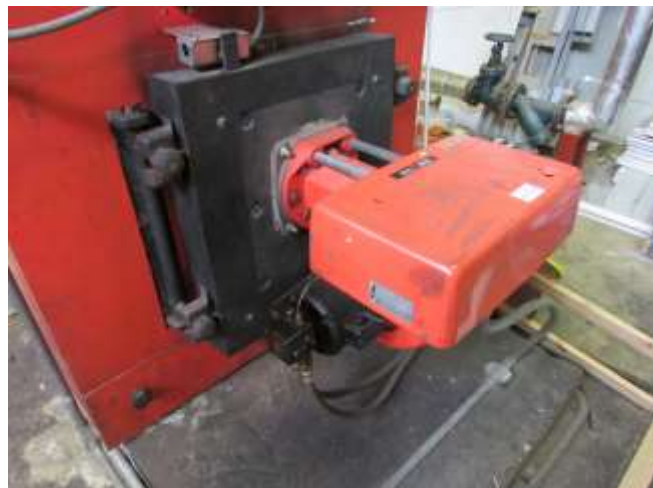
There is evidence of seals also passing where the burner fixes to the boiler.

Combustion gases are passing through the seals of each boiler.

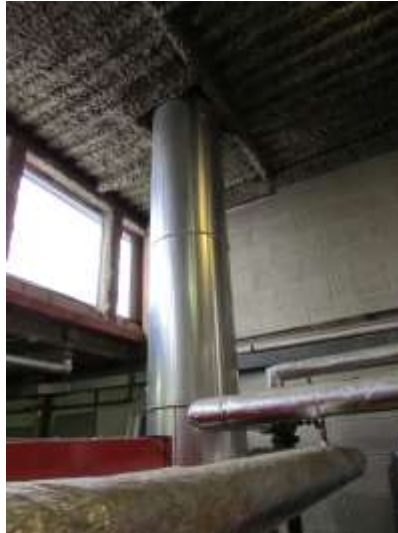
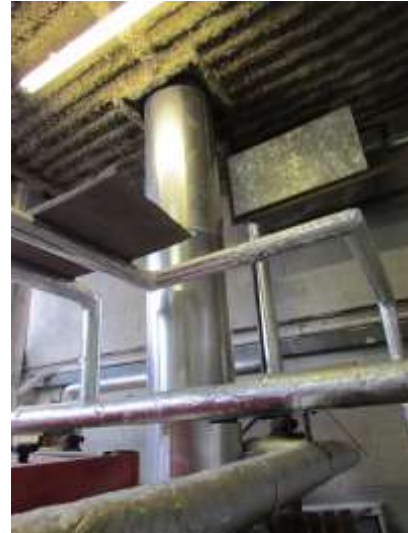
The existing flues are in a very poor state of repair and would be deemed dangerous in terms of health and safety.

Remove the existing 2no. defective flues and replace with new self supporting chimney systems including baseplates and holding down bolts in compliance with current Irish Standards and compliance. Carry out remedial work to existing flue openings through roof to make weathertight.

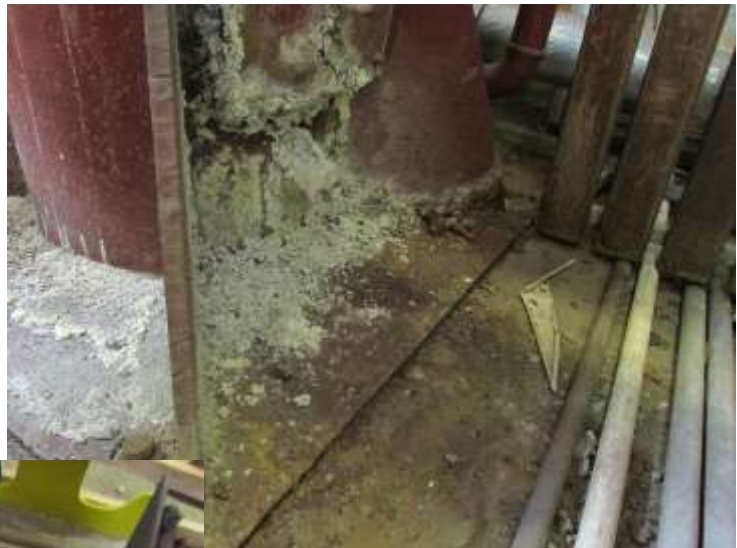
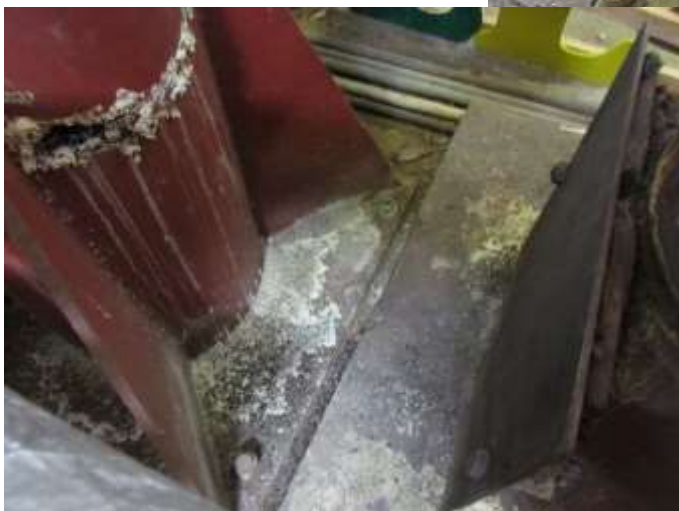
The 2No. flues are expected to be self supporting structures being held by a webbed base plate with 8No. holding down bolts. There is evidence of some of the holding down bolts now missing or not even installed during the initial installation.

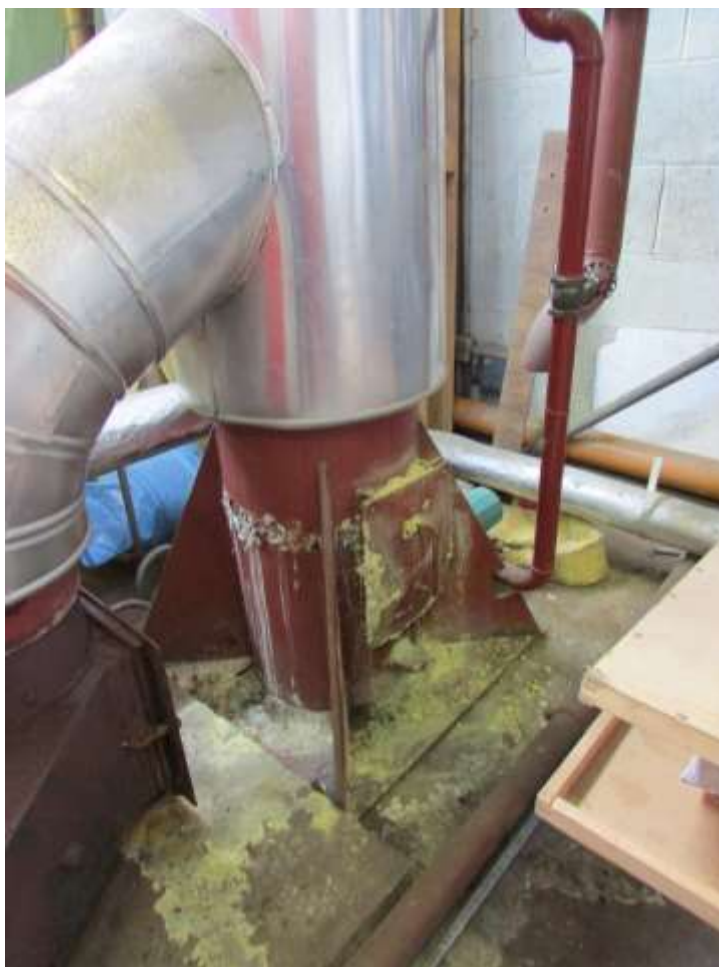
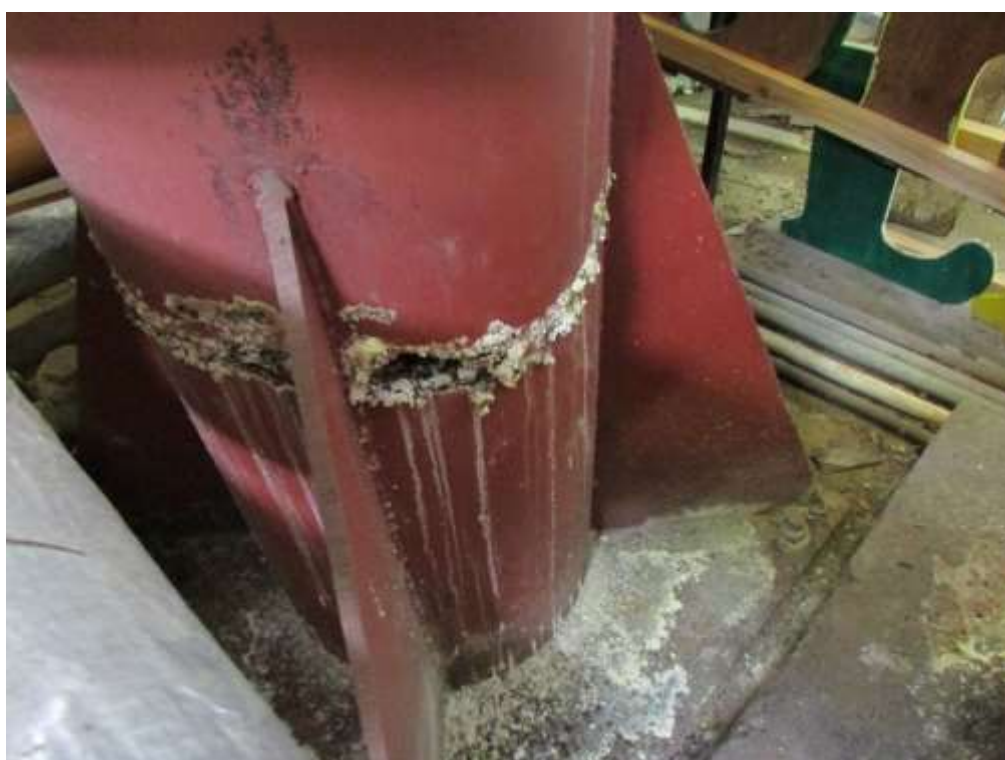
There are heavy sulphur deposits on both flue systems to the extent that both of the flues are now corroded to dangerous level.

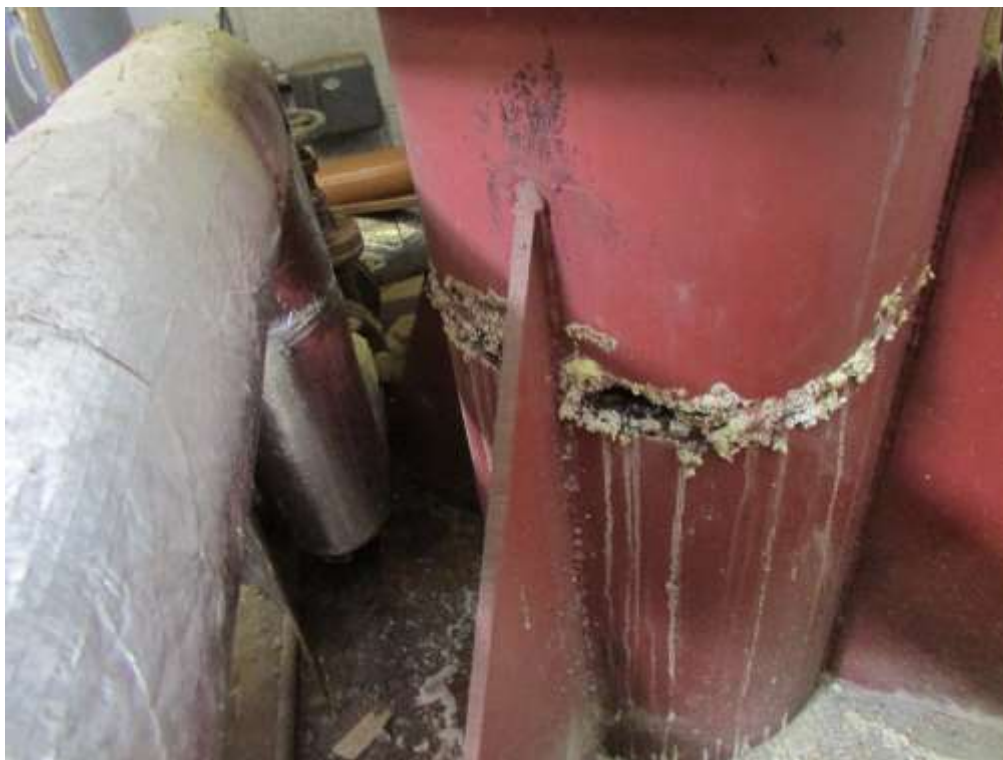
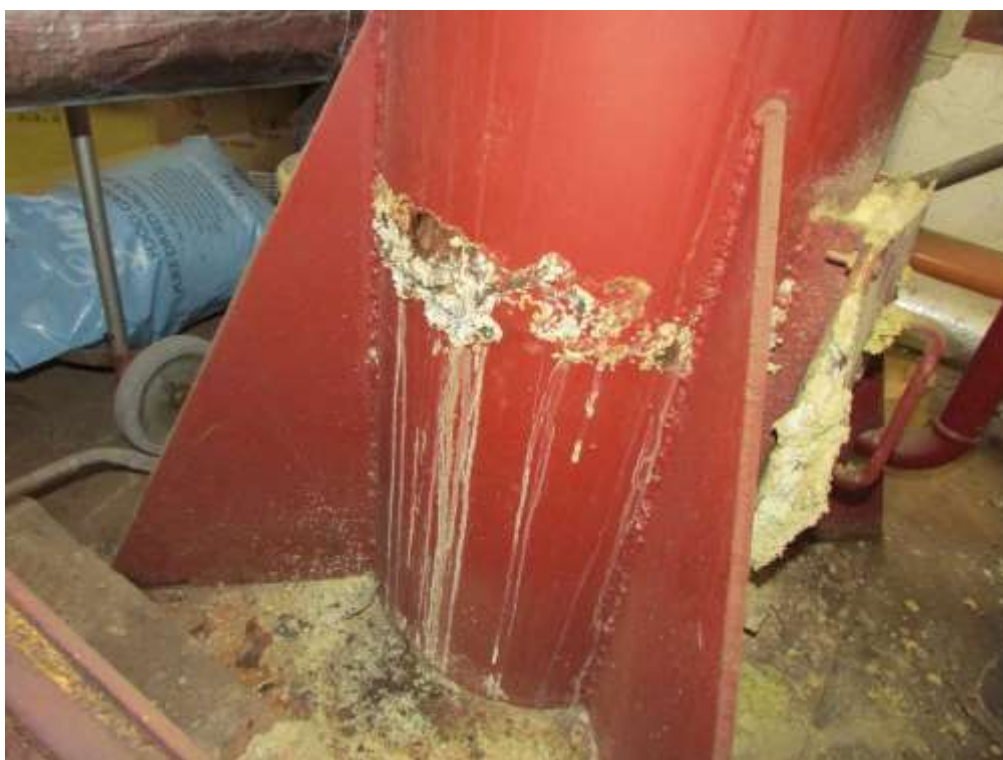
The corrosion is such that may very well have brought about the structural instability of the entire flue systems to a point that they may collapse.

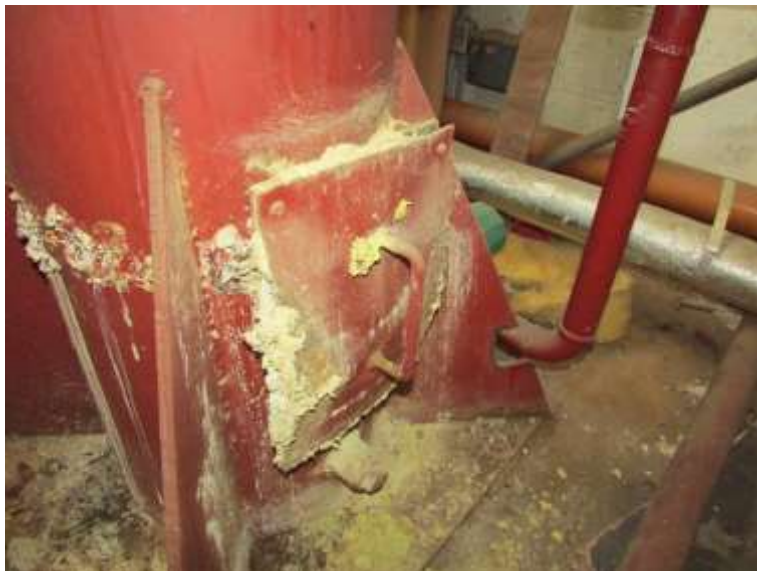
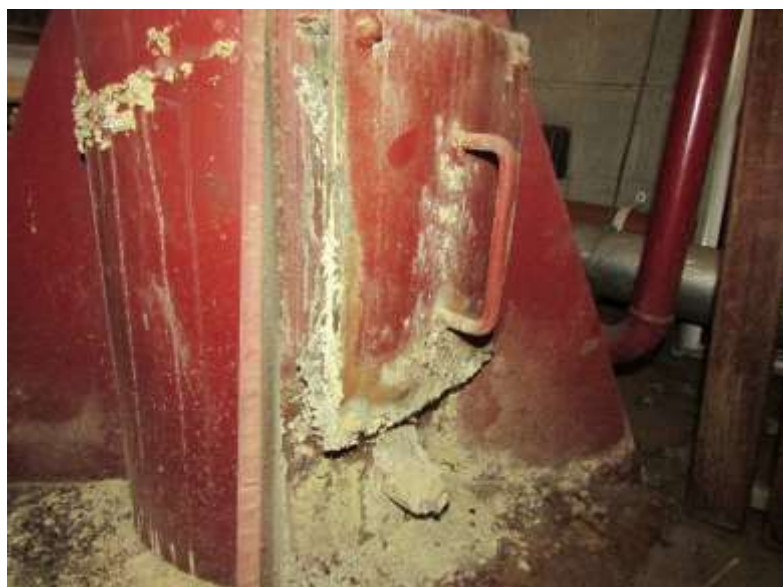
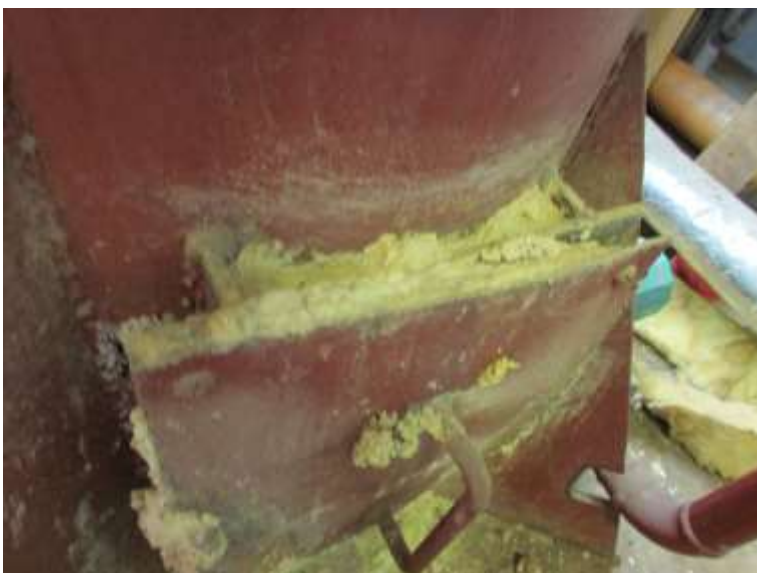
The sulphur build up at the base of each flue is that extreme that it is actually forcing the inspection doors open

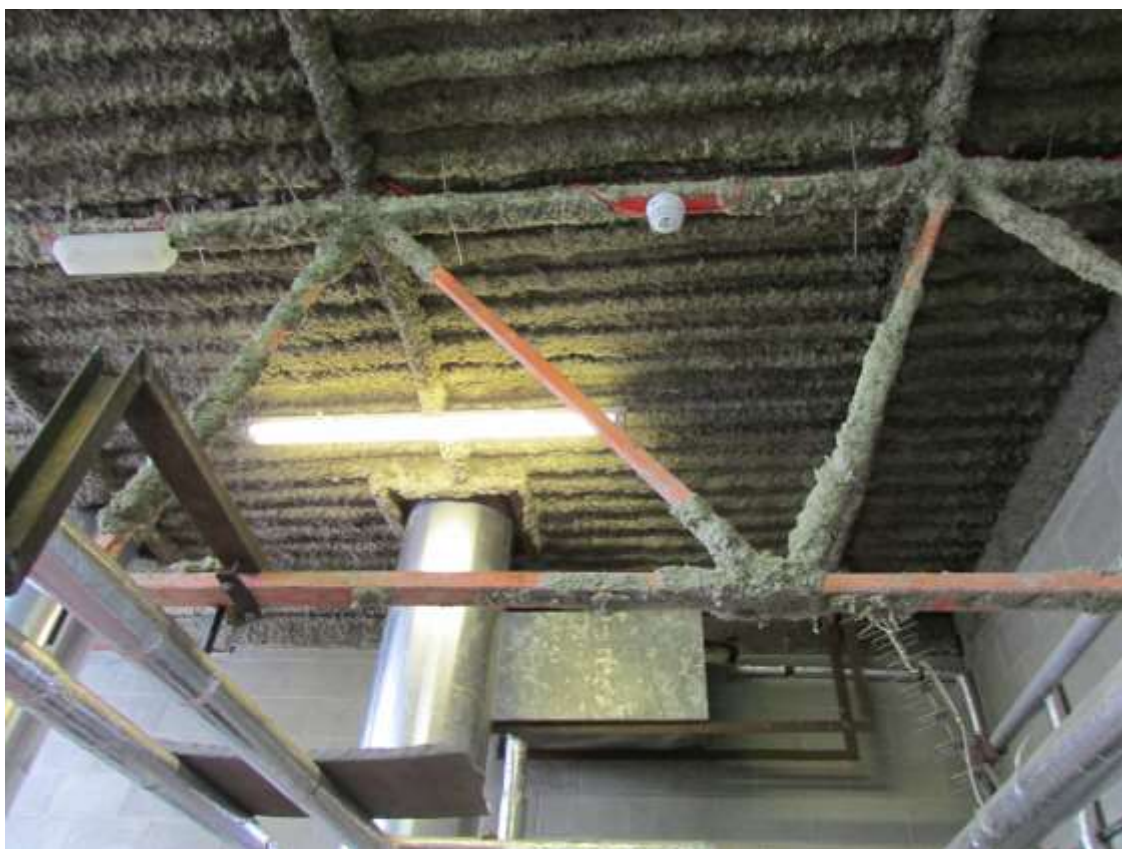
There is no physical evidence of the flues being supported in any other manner except for the base plate and holding down bolts.

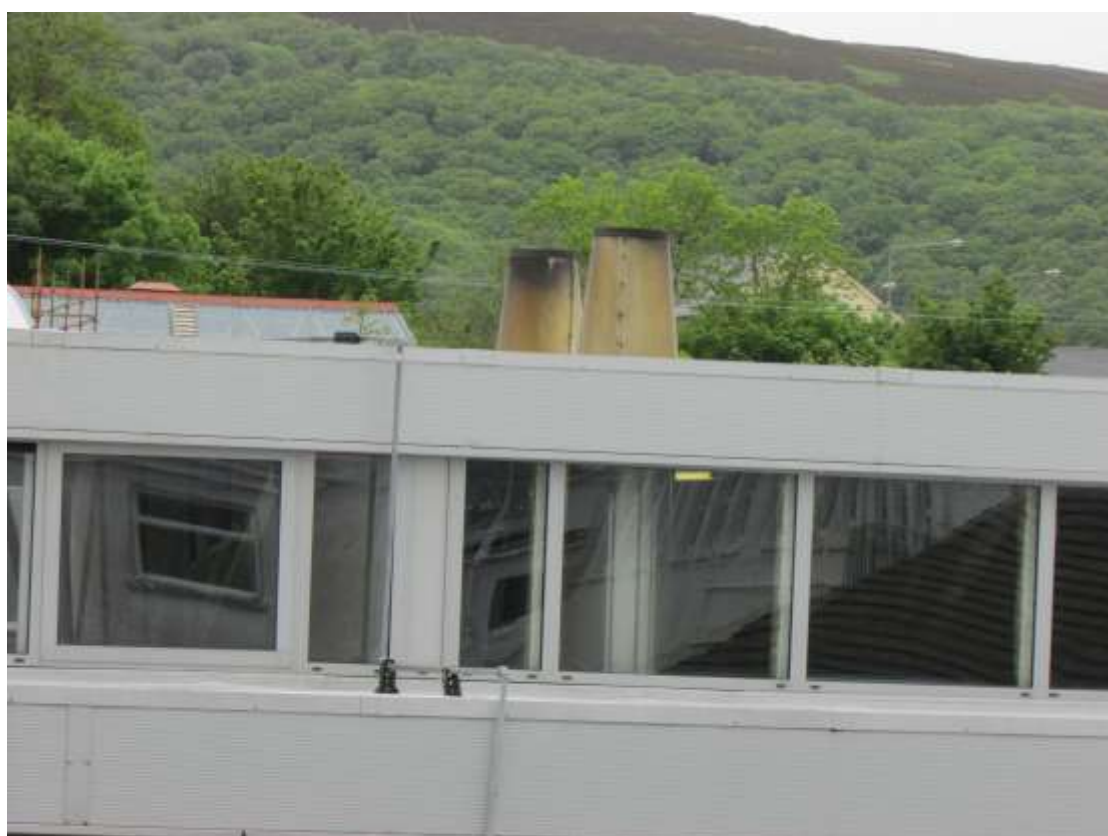
Externally the flues termination pieces shows sign of staining which is a result of in efficient burning of the fuel.

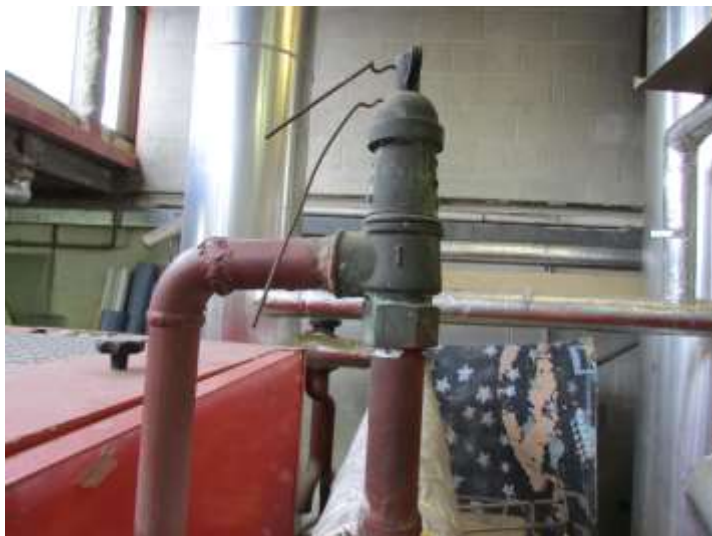
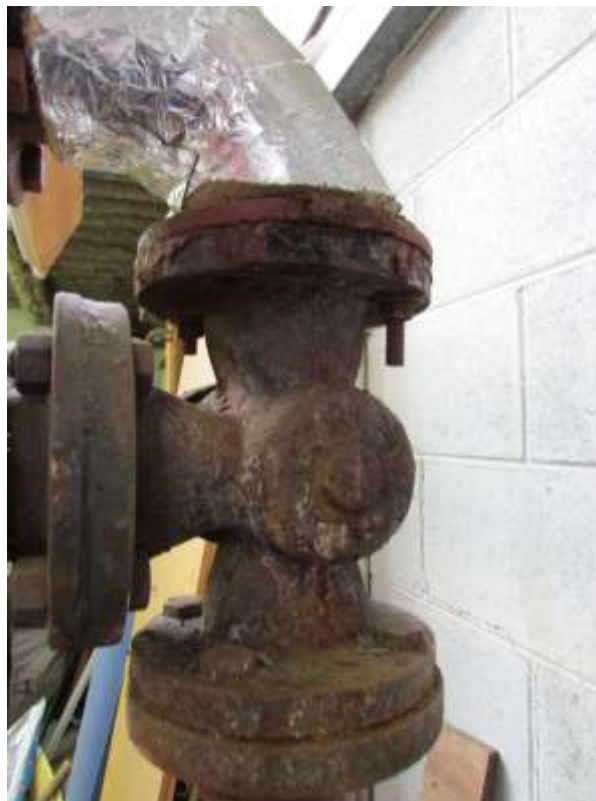
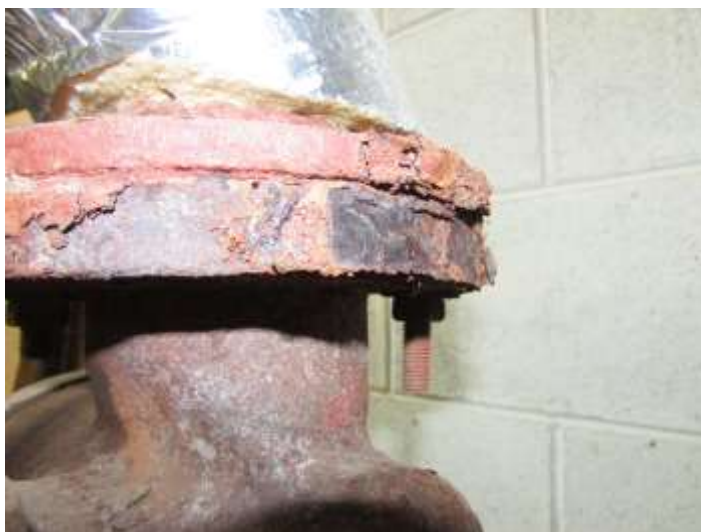
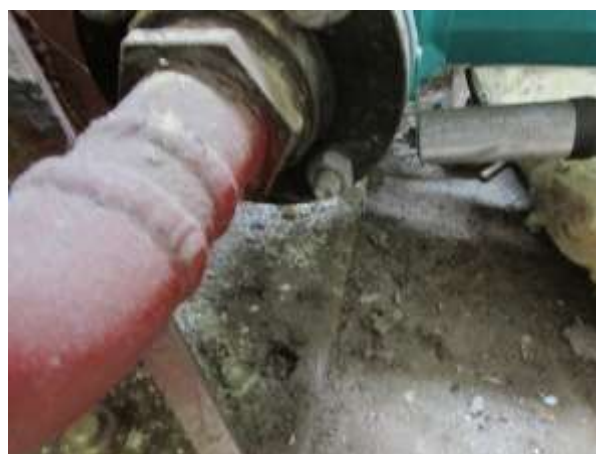
The majority of valves in the boiler house are in a below average condition with some being that heavily corroded that immediate replacement is necessary.

Remove faulty valves and replace with new.

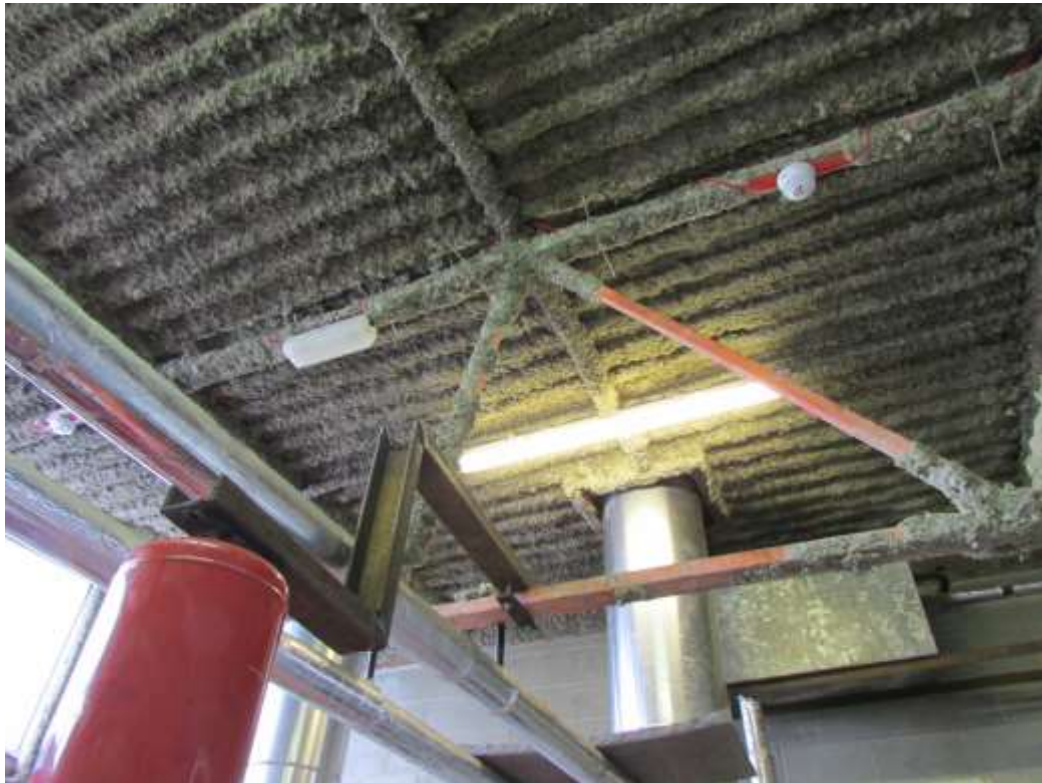
Over time sections of the steelwork that was once fire protected has been exposed to the elements.

The structural steel to be fire proofed to retain the desired fire proof rating.
