## **2.0 VISIT TO SITE**

**REPORT ON:  
EXISTING BOILERS & FLUES AT:  
CARNDONAGH CC Co. DONEGAL**

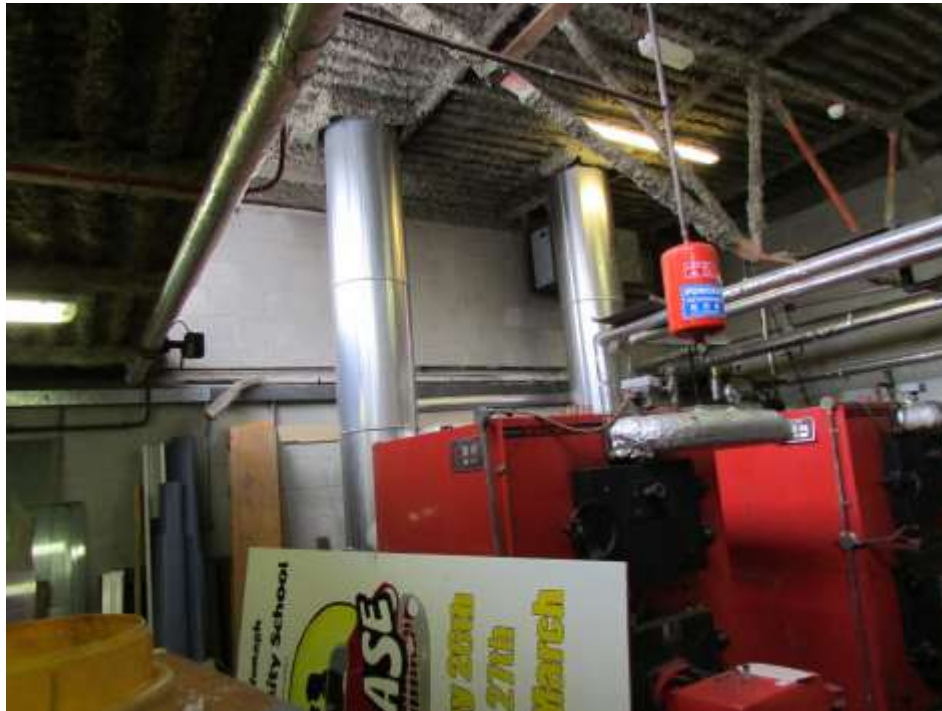
It was immediately evident entering the boiler house that there are several issues with the existing installation.

On inspection of the plant room it can be said that the burners are well maintained with the majority of pipework insulated. The installation as a whole however is deemed to be in a very poor condition.
